3 Promptly recover lifelines from damage caused by disasters

Restore water treatment facilities

Restore the waste treatment facilities

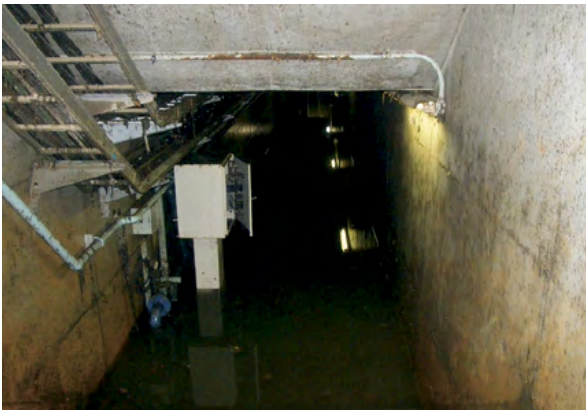
2nd water treatment piping gallery

The EBARA Group received a request from the Kanazawa City municipality to help recover the system and immediately organized a disaster recovery team. Under the directions of the Kanazawa City municipality, our team dismantled and adjusted the driving part of the plant machinery and equipment, measured the insulation resistance of the motor, disassembled and dried the motor, and removed, prepared and replaced unusable equipment. We actually completed the recovery work in two months, much faster than the predicted period of six months.

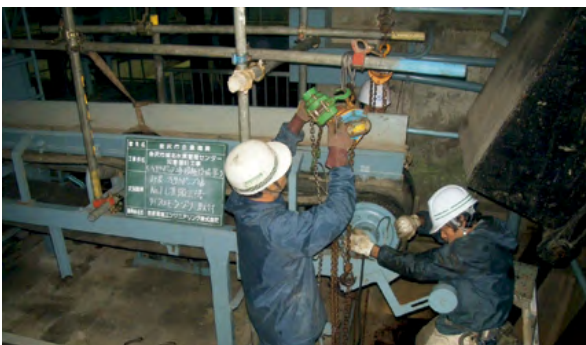
Recovery work (checking and installing the motor)
